## Linn Park, Glasgow

### Rock Slope Geotechnical Assessment and Remedial Options Appraisal Report

372568-01 (01)

JANUARY 2022

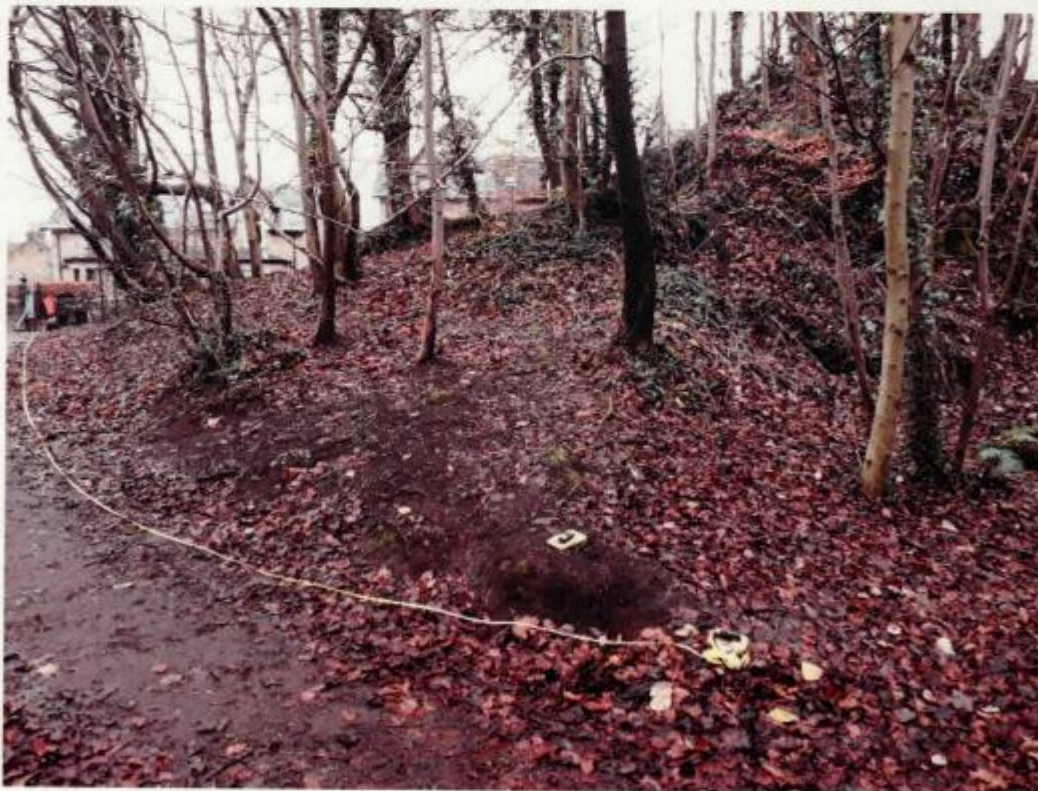
**Figure 4a: General view of Chainage 0 m to 30 m**

No evidence of instability was observed in this section. Two rock blocks of maximum dimensions 440 mm x 300 mm x 370 mm were present near the toe of the slope adjacent to the path, but there was no evidence that these had fallen and are likely to be blocks that have historically been placed there.

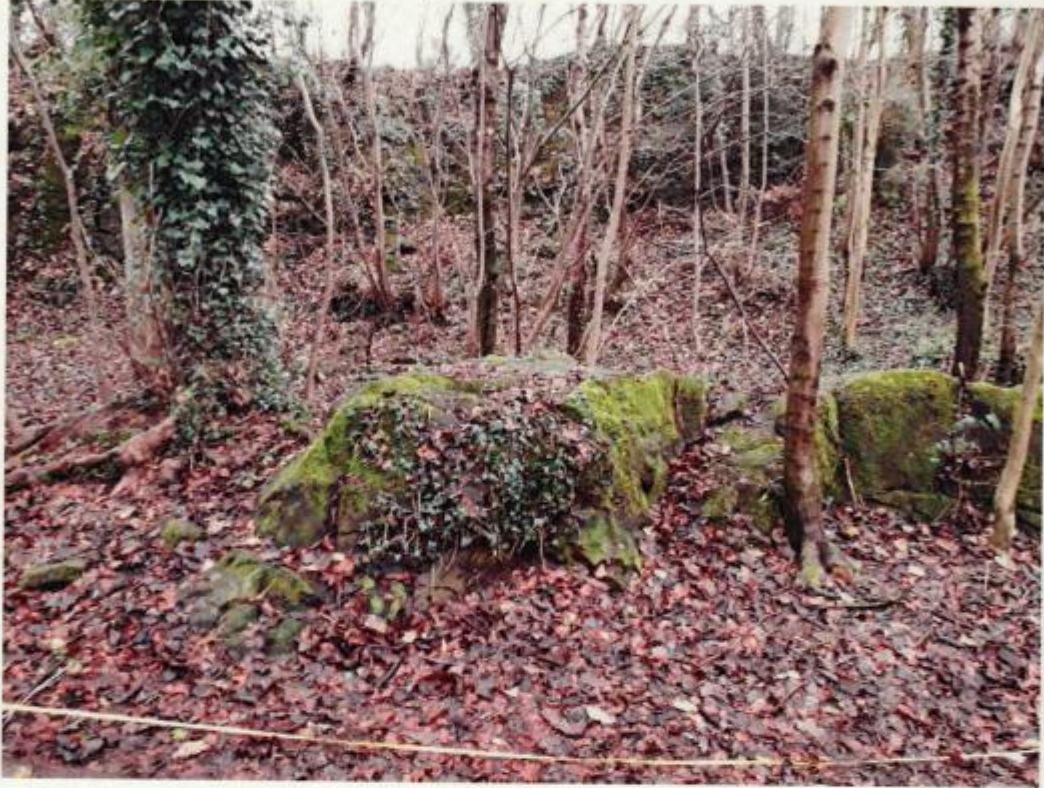
**Figure 5a: General view of chainage 30 m to 77 m**

The lower part of the slope is 2 m to 3 m in height, stands at  $40^\circ$ , and is covered by soil and vegetation. It is not clear whether this is a debris slope of spalled rock as it is completely obscured.

| Chainage | Length (m) | Slope characteristics | Hazard | Distance from hazard to receptor (footpath) | Qualitative risk rating | Reasoning for risk level |
|---|---|---|---|---|---|---|
| 30 – 77 | 47 | Re-entrant with steep rocky crags | Ravelling and wedge failures/composite failures | 7 m to 11 m | MODERATE | Potential for instability & public access area |

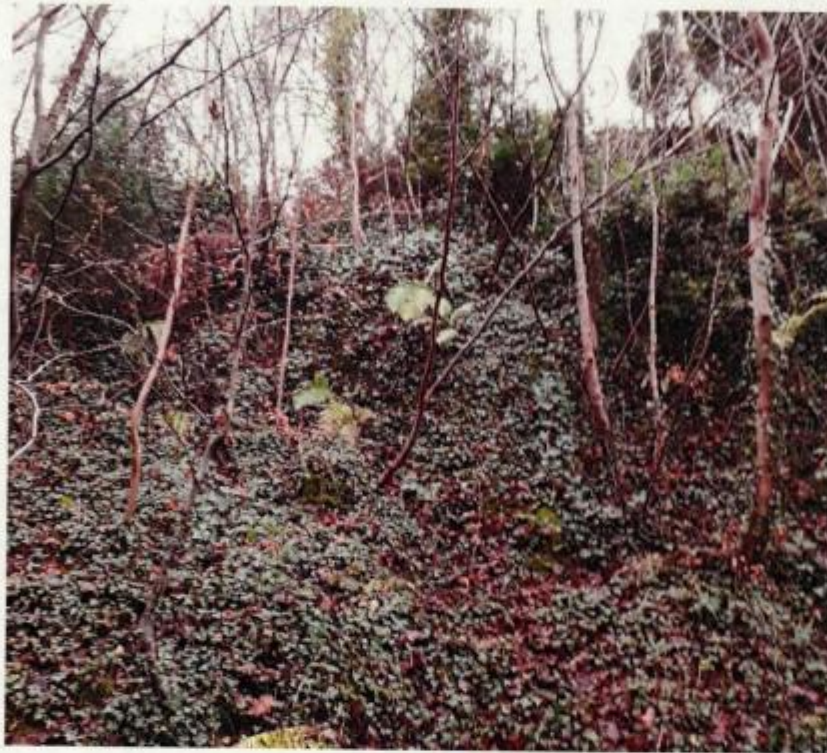
**Figure 6b: Ivy covered steep crags at top of lower slope at chainage 90 m**

At the top of the 40° slope, the ground steepens into crags with a height of approximately 4 m. This upper part of the slope appears to be rock outcrop, with ivy and moss covered exposures, but the slope is almost completely obscured by vegetation (**Figure 6b**).

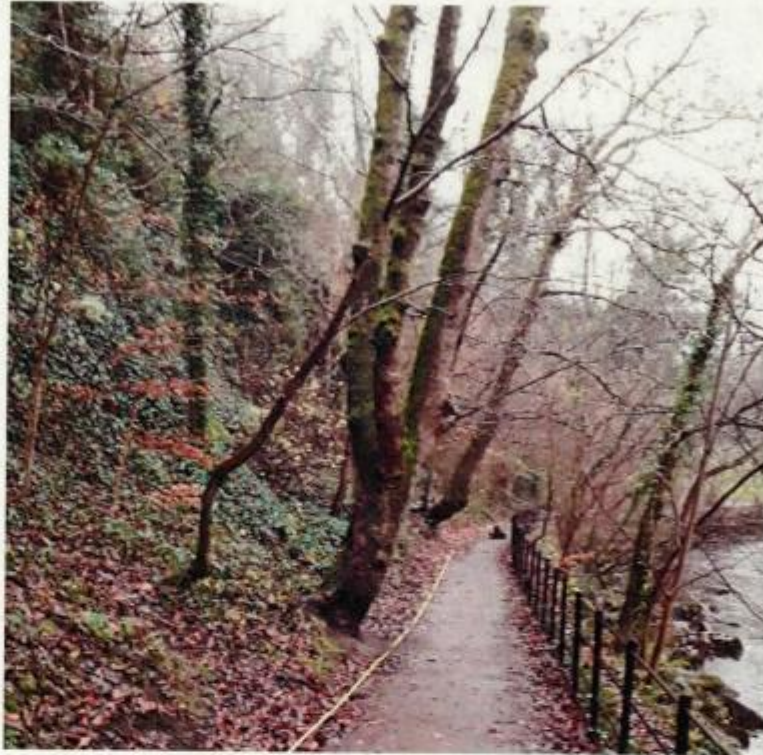
**Figure 7a: General view of lower slopes between chainages 90 m and 135 m**

From chainage 90 m, the rock crags forming the upper part of the slope start to become more prominent, and by chainage 105 m are well developed. The lower slope adjoining the footpath steepens up to 50° and reduces in height to approximately 2 m to 3 m above the footpath. Above this, very steep ivy covered rock crags are visible up to approximately 11 m above the footpath, above which the slopes are obscured by vegetation (**Figure 7a**).

| Chainage | Length (m) | Slope characteristics | Hazard | Distance from hazard to receptor (footpath) | Qualitative risk rating | Reasoning for risk level |
|---|---|---|---|---|---|---|
| 90 - 135 | 45 | 3m high 50° slope with prominent steep rock crags above. Area of failure. | | Approx. 2.6 m down 50° slope | HIGH | Evidence of instability & effectively no stand-off |

| Applicable to | Remedial options | Advantages | Disadvantages | Buildability | Estimated cost and timescale |
|---|---|---|---|---|---|
| Chainages 77m to 135m | <b>Containment:</b><br>Install a passive mesh system (drapery) on the rock face | Mesh curtain allows material to fall but contains it behind the mesh (breaks the link between hazard and receptor)<br><br>Low/negligible visual impact once vegetation has re-grown | Requires initial de-vegetation and scaling of the rock face to be protected by rope-access specialists<br><br>Requires maintenance visits (approx. every 2 - 5 years dependant on conditions) to remove material caught behind the mesh. Likely to require some degree of vegetation clearance to access mesh | Restricted access to toe along footpath and at slope crest<br><br>No access for heavy drilling plant to drill crest and toe anchors<br><br>Requires restricted access equipment.<br><br>Increased construction timescale | <div></div> <div></div> <div></div> <div></div> <div></div> <div></div> <div></div> <div></div> <div></div> <div></div> |

| Applicable to | Remedial options | Advantages | Disadvantages | Buildability | Estimated cost and timescale |
|---|---|---|---|---|---|
| | <b>Containment:</b><br>Install a rock fall catch fence at the toe of the slope adjacent to the footpath | Catch fence allows material to fail but contains it behind the fence (breaks the link between hazard and receptor)<br><br>No initial de-vegetation and scaling of the rock face required<br><br>Easy access for maintenance | Requires maintenance visits (approx. every 2 - 5 years dependant on conditions, or when rock fall is reported to have occurred) to remove material caught behind the fence<br><br>Site users may perceive risk as material fails from the face/negative PR | Access only required to toe of slope.<br><br>Standard small plant can be used to drill fence post anchors. | |
| | <b>Reinforcement:</b><br>Install an active reinforced mesh system on the rock face | Rock dowels and tensioned mesh prevent material from failing from the rock face and retains it in situ (removes hazard) | Requires initial de-vegetation and scaling of the rock face to be protected | Restricted access to toe along footpath and at slope crest<br><br>No access for heavy drilling plant | |

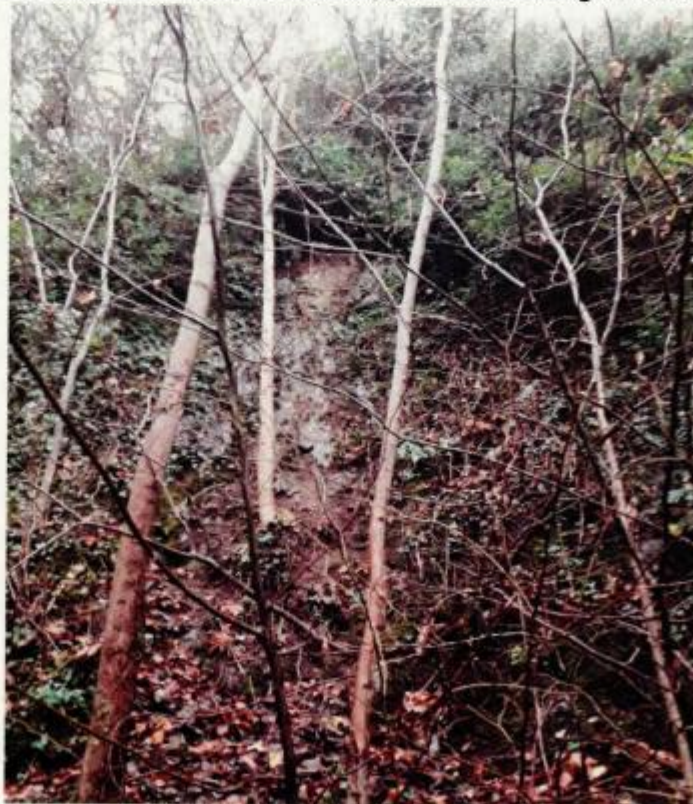
**Figure 7b: Recent failure scar on intersecting joints at chainage 115 m**

A 4 m to 5 m high failure scar is present on the rock face above the lower slope at chainage 115 m (**Figure 7b**). The failure scar is formed from intersecting planar joint surfaces dipping very steeply (approximately 70°) out of the face. This is the site from which the recent rock falls have occurred. Two large rocks of maximum dimensions 600 mm x 450 mm x 350 mm were present on the footpath at the time of the inspection. It is not clear whether these were further rock falls or uncleared remnants of the earlier rock fall.

This is the short crag which has fallen down. The creation of the crag by erosion of the underlying material was first noticed some twenty years ago.

It was then expected that the crag would break away and slide slowly to the path - which is what happened over a few days.

From the foregoing discussion it is clear that a number of feasible rock slope instability hazards have been identified at the site, and that indeed some of these instabilities have been realised, as evidenced by the recent rock falls identified around chainage 115 m.

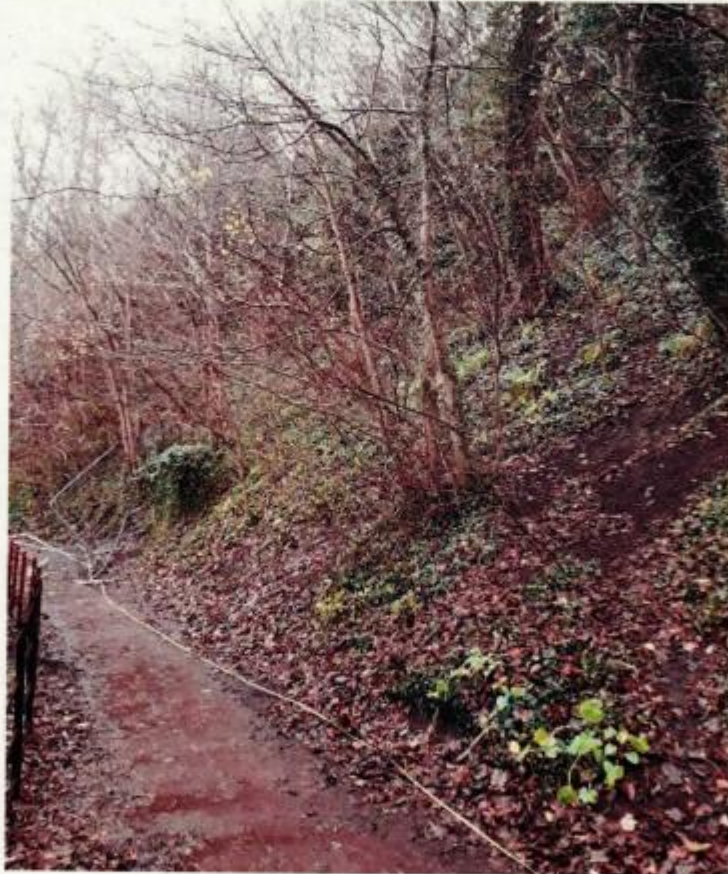
**Figure 8a: General view of lower slopes at chainage 140 m**

There is no visual evidence of the creation of other crags.

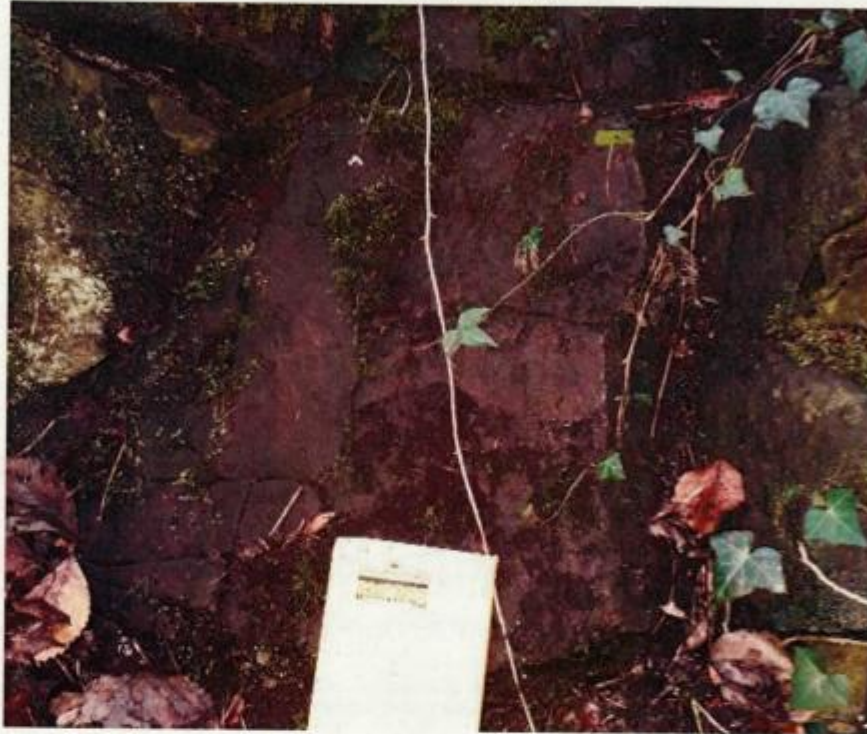
**Figure 9: Jointed and fractured dark grey microgabbro**

The rock mass is well jointed (See **Section 3.4.1**) but also contains numerous random fractures that reduce the size of joint-bound blocks. Joint-bound blocks are generally medium sized (average length of block sides 200 mm to 600 mm) and are prismatic to equidimensional in shape (**Figure 9**).

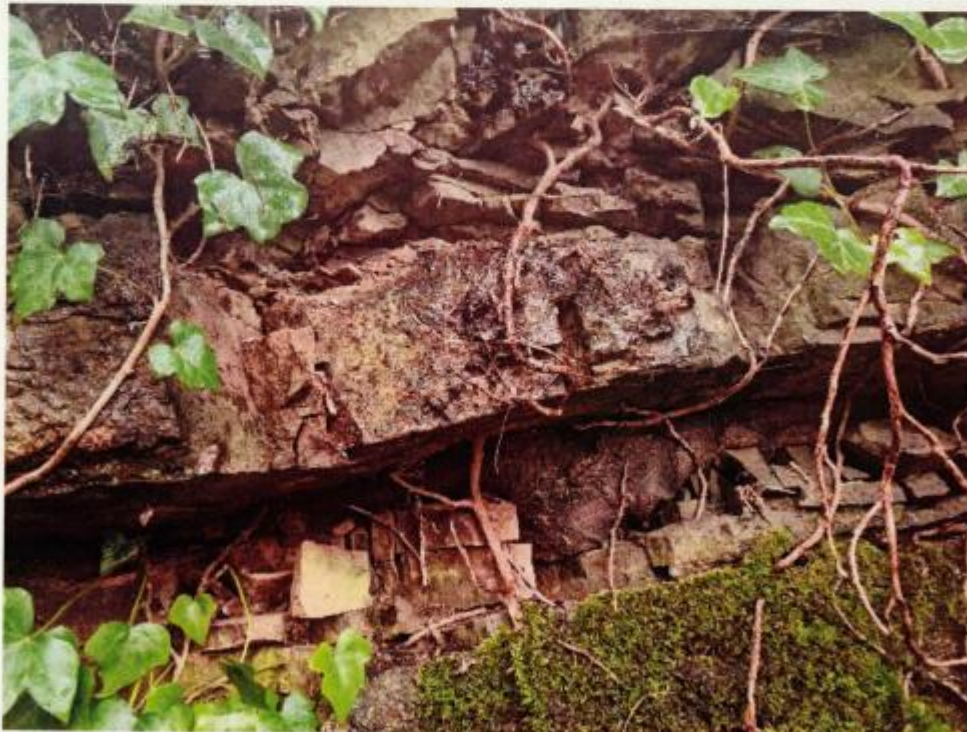
**Figure 10: Root penetration, weathering and fracture increase at the slope crest**

The degree of weathering increases significantly towards the crest of the escarpment, although the rock face is largely obscured by vegetation. In areas where the face at the crest can be inspected, there is a distinct increase in the intensity of fracturing/jointing and a reduction in intact rock strength, with pale brown discolouration. Root penetration has clearly played a significant role in mechanical weathering of the rock mass, with woody roots causing significant close spaced fracturing of the rock (**Figure 10**).

From the geotechnical inspection observations, it is clear that ravelling failure is likely to occur in the uppermost parts of the rock escarpment where weathering and tree-root action have significantly reduced the spacing and increased the frequency of fracturing to form smaller, more irregular rock blocks. In many cases rock blocks have been disturbed by root activity, reducing discontinuity strength parameters to residual values.

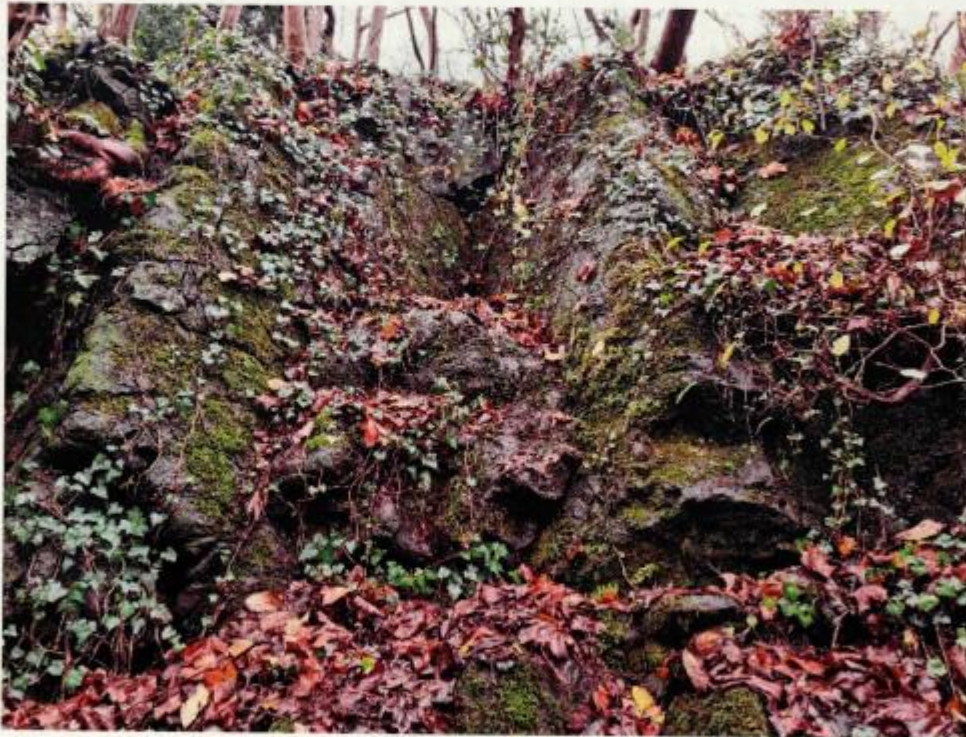
**Figure 11: Steeply dipping intersecting joints forming rectilinear columnar structures**

Within the restrictions of the limited rock exposure, it was possible to discern that the rock mass is systematically dominated by sub-vertical/steeply dipping regular sets of medium to wide spaced joints, with spacings of between 300 mm and 700 mm, but more generally 400 mm to 500 mm. These joints intersect, resulting in rectilinear or polygonal columns (columnar jointing), which are persistent at the scale of the exposure (**Figure 11**).

The kinematic analysis clearly shows that the rectilinear joints intersect within the critical failure field. Wedge failure is therefore viable. Indeed, observations of the failure surface at chainage 115 m indicate that these steeply dipping intersecting joints have formed the failure surface for the recent rock fall events. Elsewhere, apparent historic failures may be evidenced by residual edge material constrained between the intersection joints (e.g. Figure 11).

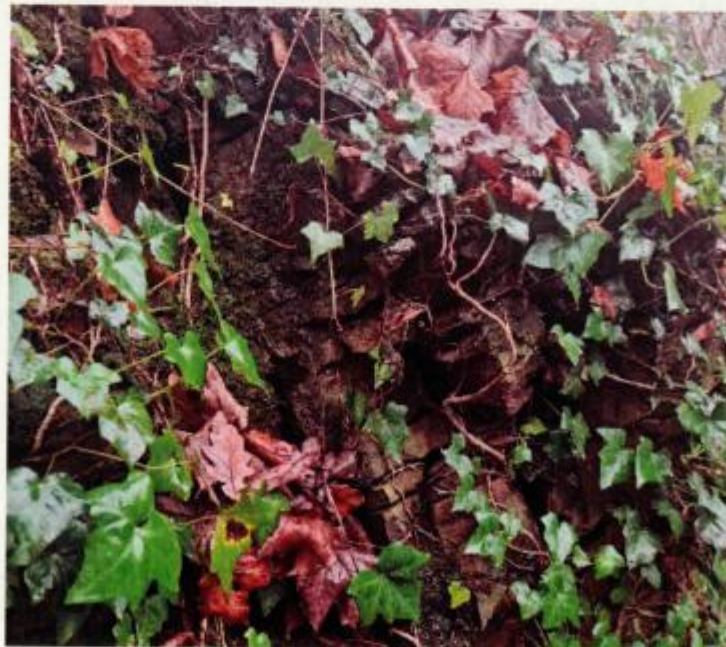
**Figure 13: Open close spaced transverse jointing of rock columns at crest of slope**

Towards the crest of the slope transverse joints have been exploited by weathering to form loose, open fractures, with an increased fracture frequency and close spacing (**Figure 13**).

The analysis clearly shows the dip of the joints is well above the friction angle of the sliding plane. Only joint set 2 (dipping WSW) marginally falls within the sliding instability field. Therefore, it is considered that sliding is unlikely to be a significant failure mechanism at the site. Notwithstanding the above, the exposures demonstrate that given the appropriate orientations, small-scale sliding of loosened column masses may be feasible (e.g. **Figure 13**).
