## Linn Park, Glasgow

### Rock Slope Geotechnical Assessment and Remedial Options Appraisal Report

372568-01 (01)

JANUARY 2022

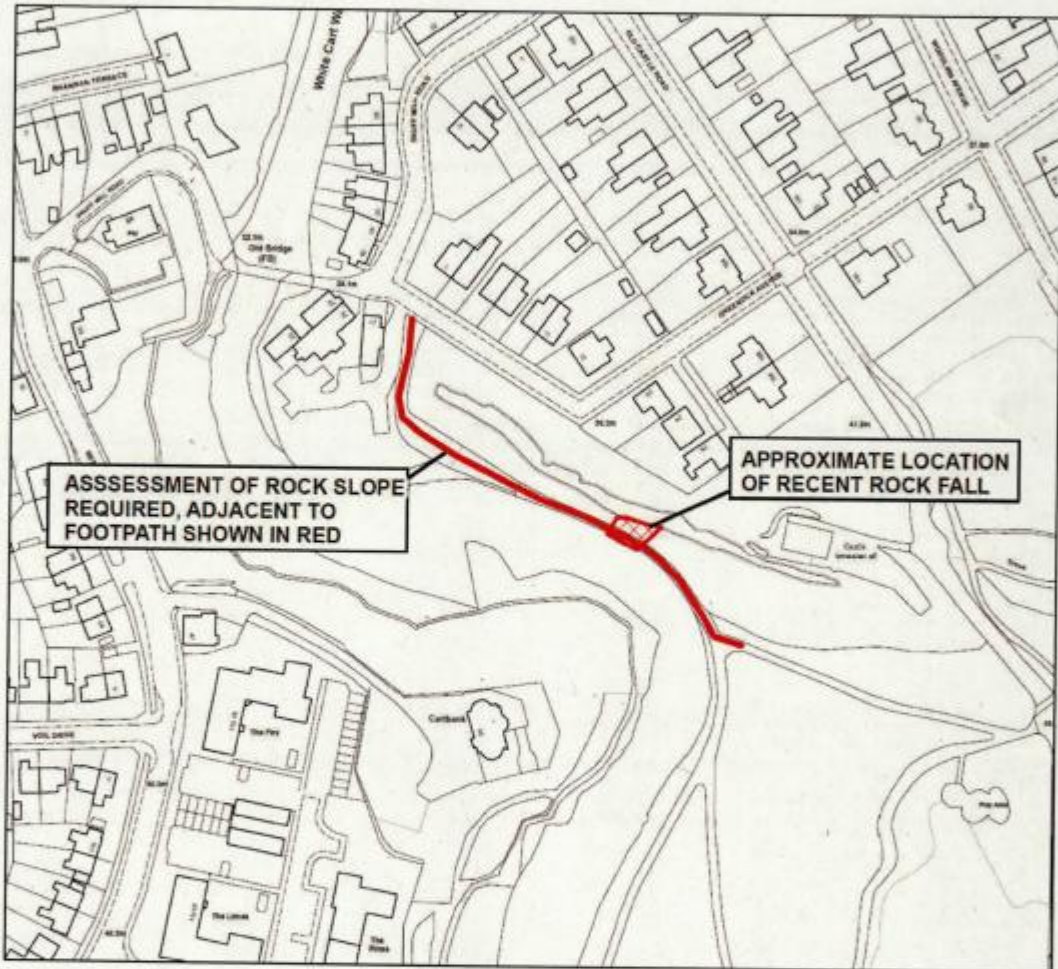
**Figure 1: Site Location Plan**

Chainage of  
rock fall 115m

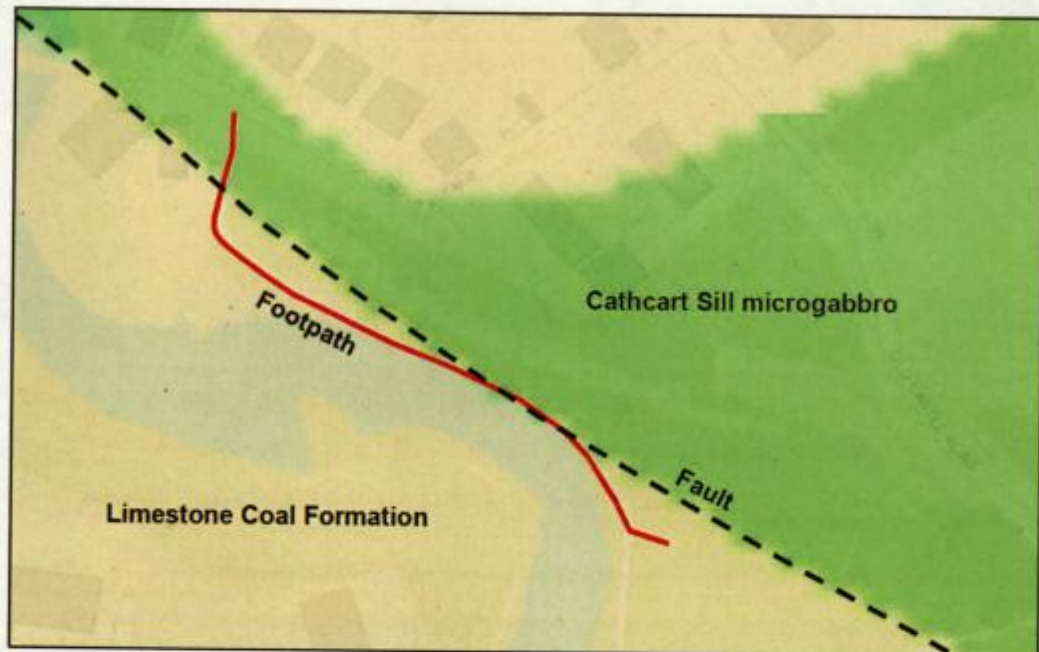
Figure 2: Annotated extract of BGS bedrock mapping showing footpath location

Publicly available British Geological Survey (BGS) records indicate that the craggy escarpment is formed from the Cathcart Sill, an olivine-microgabbro igneous intrusion of late-Carboniferous/early-Permian age. In BS5930 this rock type is identified as Dolerite.

Whilst Devensian Glacial Till is present across the wider area, it is absent from the crest of the crags in question where it has been removed by erosion.

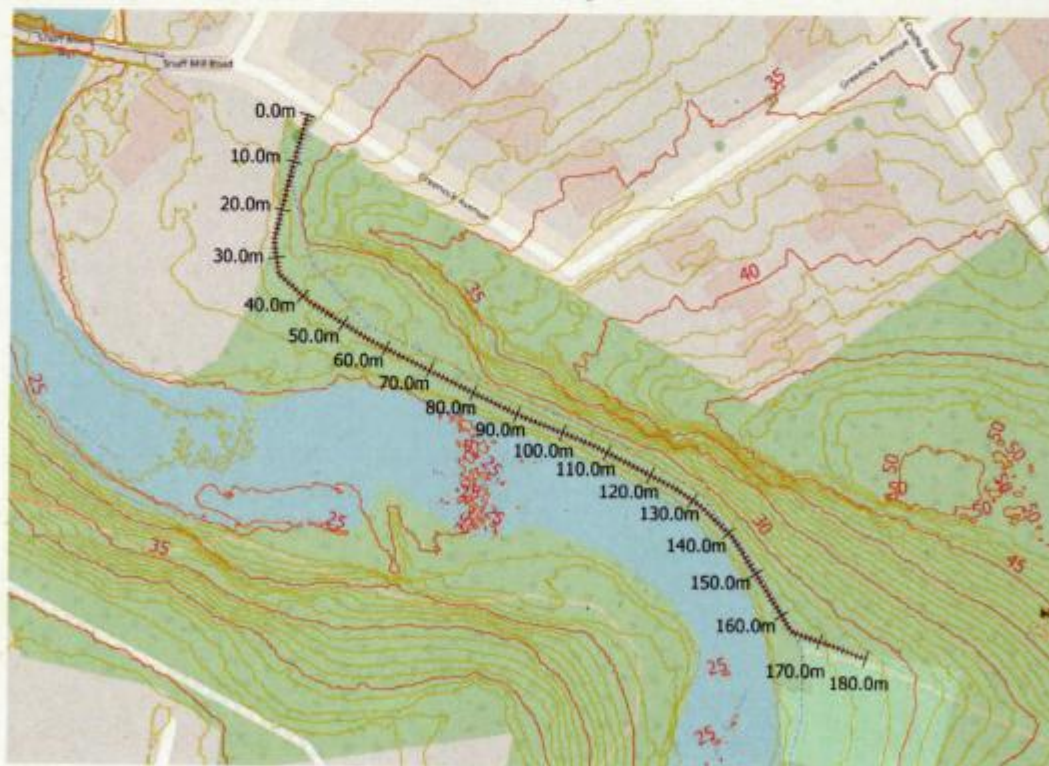
**Figure 3: Plan showing terrain data and chainage.**

Inspection observations have been recorded with reference to a chainage (in metres) measured along the footpath at the toe of the escarpment from the gated entrance to the footpath adjacent to Greenock Avenue (chainage 0). The chainage extends southeastwards along the footpath to chainage 180 m, close to the confluence of the footpaths to the south of the remains of Cathcart Castle, as shown on **Figure 3**.

The escarpment is formed from a rocky ridge that trends northwest-southeast and increases in elevation from 35 m in the northwest to 50 m in southeast. The footpath elevation at its toe remains fairly constant at 28 m to 29 m (**Figure 3**).

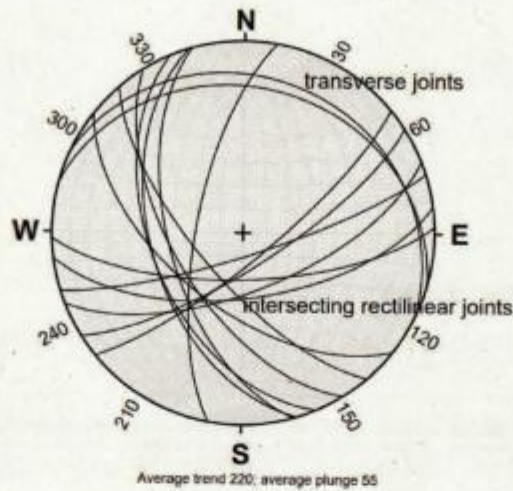
**Figure 12: Stereographic projection displaying the discontinuity sets present across the site**

A summary of the discontinuity sets and intersections are shown as a lower hemisphere equal area stereographic projection in **Figure 12**.

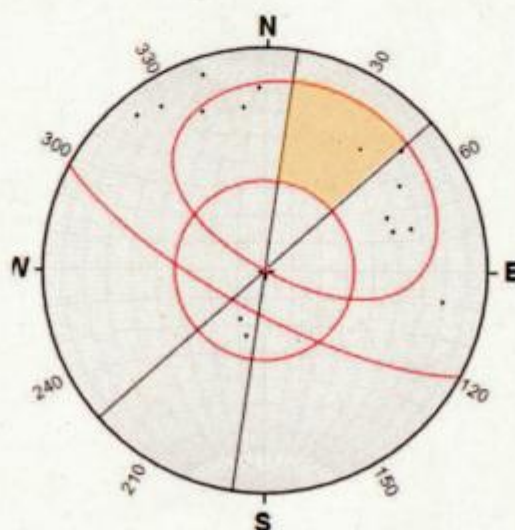
The analysis clearly shows the dip of the joints is well above the friction angle of the sliding plane. Only joint set 2 (dipping WSW) marginally falls within the sliding instability field. Therefore, it is considered that sliding is unlikely to be a significant failure mechanism at the site. Notwithstanding the above, the exposures demonstrate that given the appropriate orientations, small-scale sliding of loosened column masses may be feasible (e.g. **Figure 13**).

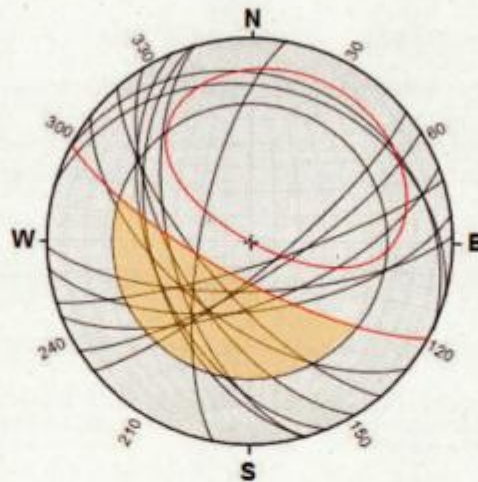
The roots of trees are probably what triggered the wedge failure - viz push the individual rock boulders out.

The kinematic analysis clearly shows that the rectilinear joints intersect within the critical failure field. Wedge failure is therefore viable. Indeed, observations of the failure surface at chainage 115 m indicate that these steeply dipping intersecting joints have formed the failure surface for the recent rock fall events. Elsewhere, apparent historic failures may be evidenced by residual edge material constrained between the intersection joints (e.g. Figure 11).

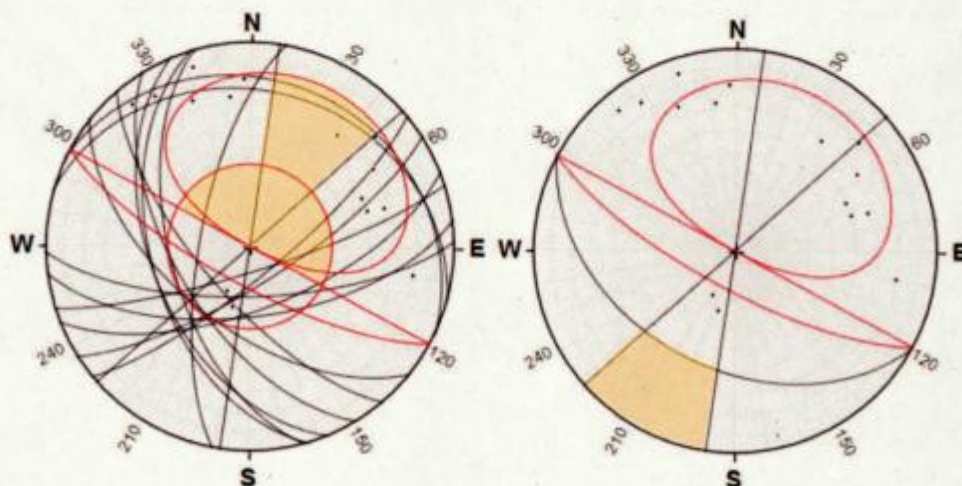
Kinematic analyses indicate that toppling (both direct and flexible) are unlikely to be feasible modes of failure based on the available discontinuity data.
